Failure of the Front Frame Tubenuts

STOA Tech Tips

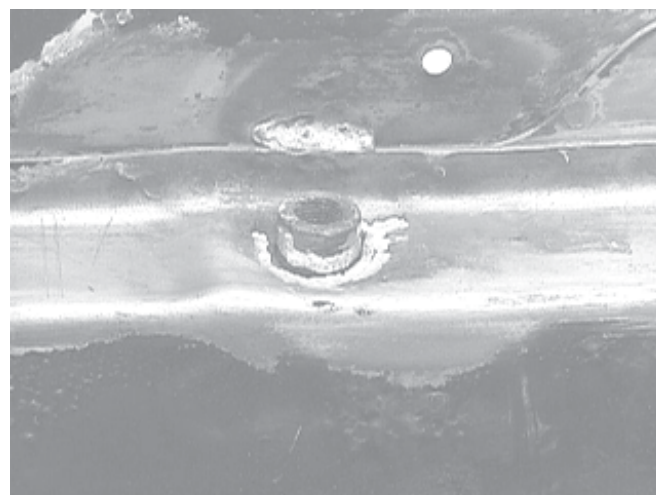
Figure 1. This is a shot of the front frame rail with the tubenut protruding. The original weld has been ground away in preparation for the installation of a reinforcing plate. It's hard to get a picture that shows the depression in the top frame rail surface but it is evident in this photo. It's much easier to spot when you've seen it on a Tiger.

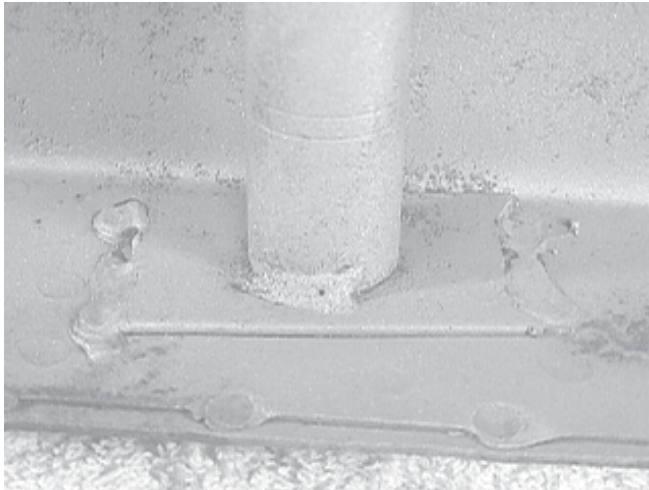
Figure 2. Here's a rarely seen piece of your Tiger. This is the inside of the front frame showing the lower framerrail, the tubenut, and the small sheetmetal flange between the two. In typical failures, these components move downward as a unit. The outer spot welds tear away from the top portion of the outer flange and the loading shifts 100% to the upper flange. At that point there will not be any outward indication. As the crossmember attachment bolt continues to pull down on the tubenut, the top surface deforms and eventually the top weld breaks.

Although the typical cracking of this tube to frame weld and the depression that forms in the top of the frame rail is the "observable" damage from this mode, the more critical failure is that of the lower frame flange connections. The lower frame flange is a spot welded assembly and when these welds fail the bottom of the frame begins to separate from the top. The result is that the tube begins

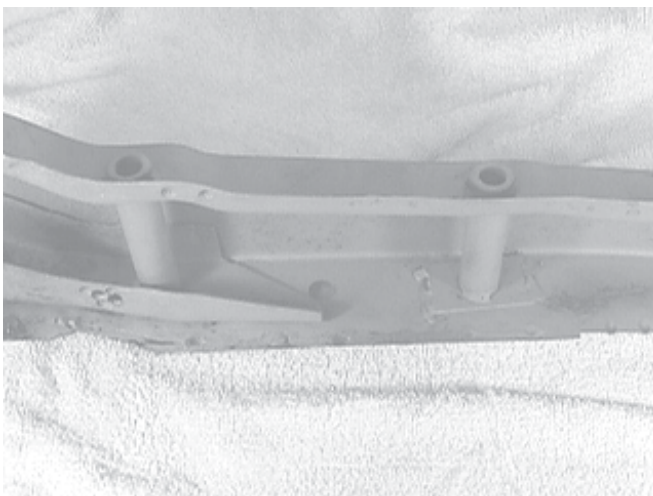
Figure 3. This shows both front and rear tubenuts and the stamped frame reinforcement inside the frame in the area of the hump and motor mounts. The plug welds you see on the side in the area of the rise connect to this internal stamped member. (Too bad the designers didn't bring this piece forward to the front tubenut!)

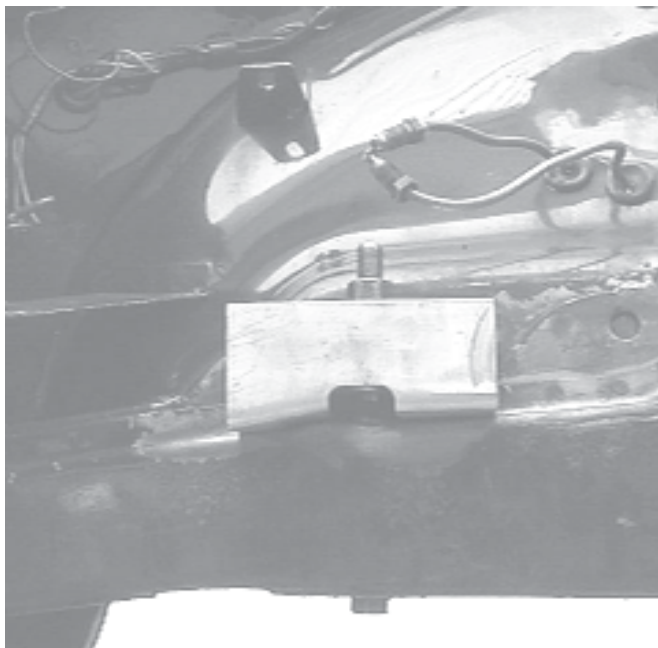
Figure 4. Here's a shot of my aluminum tool which helps pull the lower flange back into position. It is shown with the 7/16 bolt in place to apply pressure in the proper places. It does not pull the depression out of the top of the frame. That will be covered with an added piece of plate.

Next comes the process of pulling the lower frame flange and tubenut back into proper position. I made a tool to accomplish this task. It fits both top frame rail surfaces and spreads the load so that a bolt can pull the lower frame and tubenut together back into position (Figure 4). You want to pull the tubenut and lower flange back up to the point where the lower flange is again flat. At that point you can clamp the outside edge of the lower frame rail near the front tubenut in place with a couple pairs of Visegrips.

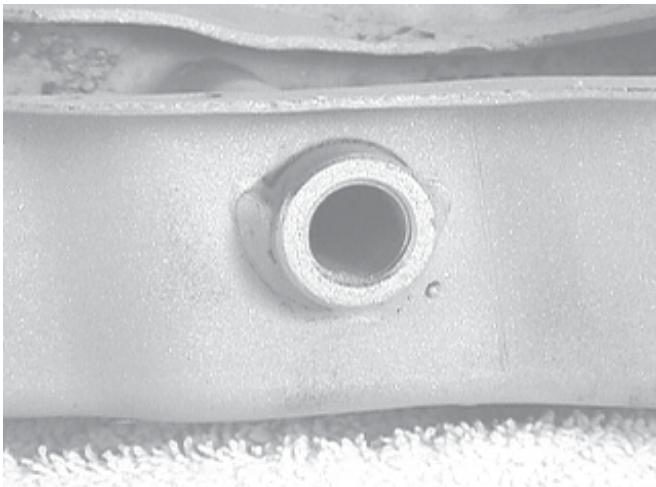
Figure 7. This is a closeup of the front tubenut "as built" by the factory. Notice that the weld is only on the outside of the tube where it was accessible, and furthest from the vertical flange which could have provided additional strength.

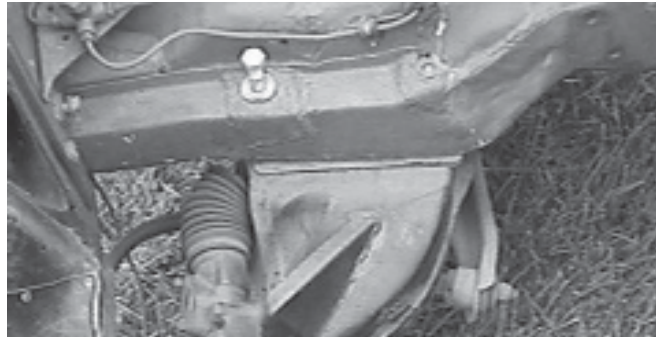
to sink in the top flange long before the cyclic fatigue causes this top weld to fail. In fact, it has been observed that the top frame rail always becomes depressed in the welded area of the tubenut once failure begins to occur. Repairs to this area are observable on the factory race Tiger #55 currently owned by Bill Miller.

Figure 8. I'm sorry that this photo is not clearer, but this is a picture of the factory race car #55, now owned by member Bill Miller. It does show that the structural failure areas discussed in this Tech Tip were relevant even in the first year of racing activity. My illustrated methods may be slightly different, but the message is the same.
