TECHNICAL TIPS

ON THE SUNBEAM TIGER

February 1996

General Discussion of Tiger Unibody and Examination for Faults

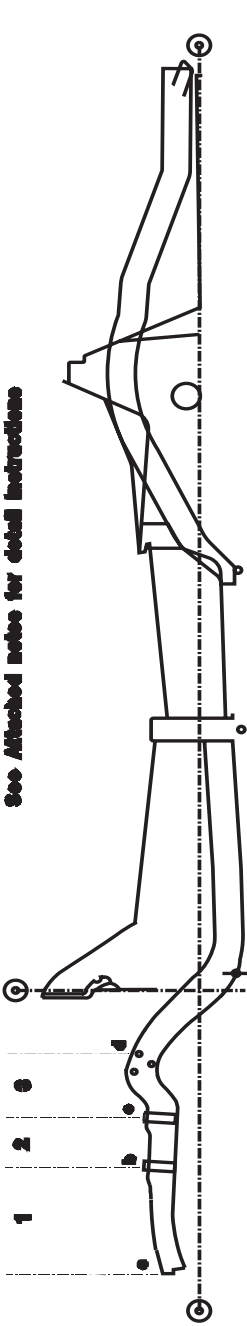
Figure 1

Fatigue damage is normally restricted to that area of the front frame horns, forward of the rear crossmember attachment bolt. On the attached diagram (fig. 1), This would be areas 1 and 2, from "c" toward "a". Accident damage in this area will commonly be more obvious, with bent frame rails, cracks, etc. Even after most body shops repair this obvious damage, some subtle damage may remain in the arched portion of the frame rails, in area 3, from "c" to "d". The Tiger may appear "fixed" but a substantial displacement may still be present which will alter the front end alignment and handling of the car. Simply striking a curb hard enough with the front crossmember can product bending in that area of the frame. This bending is frequently downward, slightly shortening the wheelbase, or it may include a narrowing component which causes the frame rails to be closer together and altering the location of the upper suspension components. The best way to check for bending in this area is to closely compare an undamaged chassis, and if possible, the fabrication of sheet metal templates (shades of NASCAR).

The primary front suspension attachment points are the four bolts that hold the cross member to the frame assembly. They screw into four threaded tube inserts that are welded into the frame rails. The attached diagram of the Tiger chassis indicates these as b and c. The areas of concern for the frame inspection are noted by numbers and letters on the diagram. The primary front frame fatigue inspection area is that between the threaded insert tubes for cross member attachment, and the front bumper(a). This is a rather weak area of the frame due to the small space for the sheetmetal flanges and spot welds and the change of the structural materials in that area. In addition to the possible overall change in frame curvature, the other thing you are going to be looking for in this area is the failure of the tube insert welds, (normally the front "b" tubes), allowing the tubes to pull down through the top frame surface, into the frame, and for the outside bottom of the frame rail flange to begin de-laminating in area 2. If the cross member is out, the movement of the tubes will be detected as downward swelling of the frame at any of the four threaded insert locations (It was originally very flat in this area). If the cross member is installed, movement can be detected by close examination of the weld area surrounding the inserts at the top of the frame for cracks and local bending.

As the associated de-lamination occurs, it normally progresses forward on the frame, popping spot weld after spot weld, toward the front bumper mount. This failure mechanism is also possibly the result of cyclic fatigue resulting from applying the brakes several hundred thousand times. Each brake application applies a torsional load to these attachment points, which can eventually lead to structural failures.

De-lamination of the front frame horns and bumper mount in area 1 between a and b is a very common problem. It is not as serious as the suspension attachment tubes, but will cause problems if not repaired. If left unchecked, this failure will eventually work it's way back to area 2, and into the suspension mounting tubes.

At the rear of the chassis, the most frequent failure is the cracking of the angle shaped reinforcement between the front spring eye bolt and the inside surface of the frame X. This is indicated as area 4. Another important rear area to examine for damage is the area behind the seats as the floor pan rises up to the shelf behind the seat. The area to be examined is that which contains the spot and tack welds between the sub-frame and the floor pan. This is the area of load connection for the front of the rear springs. It has to transfer the majority of the rear suspension forces to the chassis. Commonly, these welds have pulled out of the floor pan on Tigers that are rusty or have been used for drag racing or other hard acceleration which resulted in wheel hop.

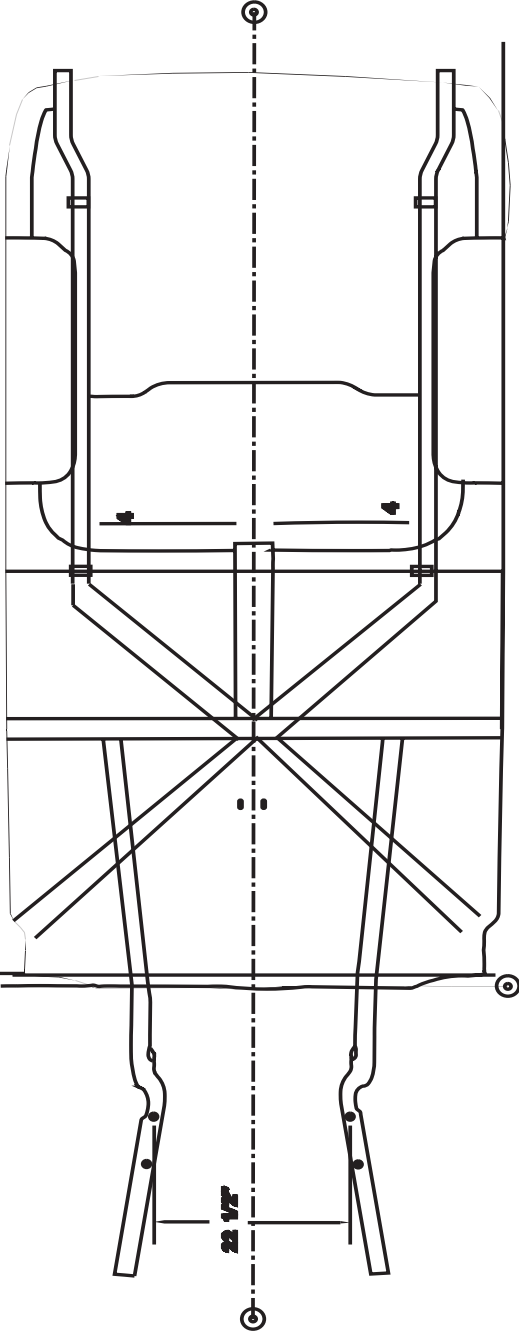
Figure 2

Please note the lower diagram, (fig 2). Measurement between the centers of the two rear threaded insert tubes should be approximately 22 1/2 inches. After a collision or other front end damage, it is common for this measurement to be reduced by as much as 3/4" or more. The crossmember assembly will also show a corresponding movement

between the rear two bolt holes. High mileage and aggressive shocks and spring rates can also cause this compound degradation due to simple fatigue without any accident damage. A fatigue collapsed frame and crossmember will also show a related reduction in the measurement of the distance between the shock towers, causing problems in obtaining proper front end alignment. The measurement between the rear top corners of the shock towers should be approximately 28". Spreading the frame and crossmember back to original specifications is necessary in order to obtain proper camber adjustment. A major question is the advisability of bending or spreading the frame of a Tiger that has already been repaired and "finish" painted. This work and any other frame repair should be among the initial steps of any serious restoration project. The challenge associated with repairs done to "finished" cars is that the repair displacements required, may tend to crack other nearby welds and warp body/fender panels because of the Tigers unibody construction methods. If you are in this situation it would be advisable to consult a frame repair shop before applying the jacks.
