Figure 1. Here are the pieces that make up the MTE Reinforcement Kit. They include three plates for the rear spring mount area for both sides and the plates for the front Tubenuts at the front crossmember.

ModTiger Engineering - Tech Tips

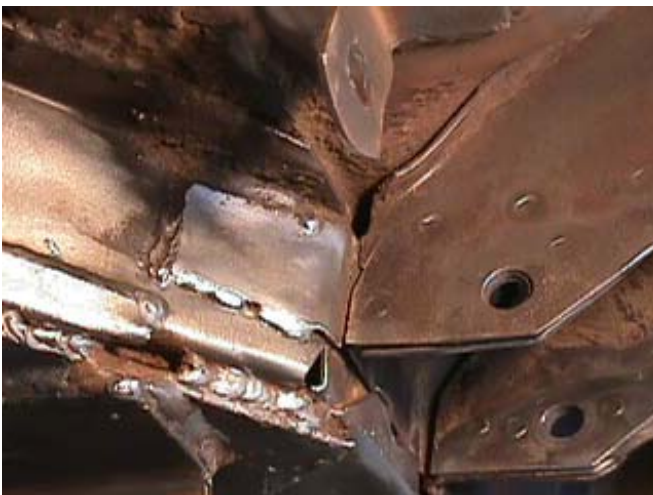
Before we get into the actual procedures to install the various pieces of this kit, I'm going to show you a few pictures that will help you decide if you need this type of reinforcement now, if you can put it off for a while, or your problem is even more serious. Figure 2, below shows the typical Tiger frame in the area of the rear spring attachment. The area shown has obviously been cleaned up and stripped of undercoating. It is much harder to see this failure when it hasn't been cleaned. It remains one of the most common fatigue failure points in the Tiger.

Figure 2. This is what most owners will find when they examine the front mounting area for the leaf springs. This crack is only the most visible failure point. It occurs because this location is a natural "hinge" in the chassis structure where the rear sub frame joins the body tub and X member.

The MTE Structural Repair Kit is designed to Bridge the natural hinge existing in the Tiger chassis. The plates are to be formed as required and welded to the various chassis components thus carrying the stress loads across this area. Appropriate repairs to minimize existing damage and separation of chassis components are the responsibility of the owner. If you find damage greater than that pictured, professional chassis repair is recommended.

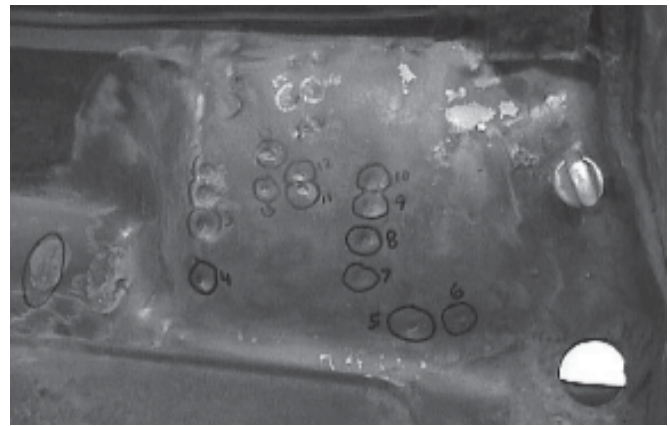
The photo's below are inside the passenger compartment behind the seats. The rear subframe assembly is spot welded to the body tub and these welds are what you are looking at. When the frame tab (shown in Figure 2) cracks, these welds begin to assume the structural loading. They begin pulling apart and the local "dishing" of the floor pan leads to the cracking evident in these photographs.

Figure 3. Here we have an overall shot of the spot welds behind the drivers seat. You will have to do a lot of cleanup to get down to this level.

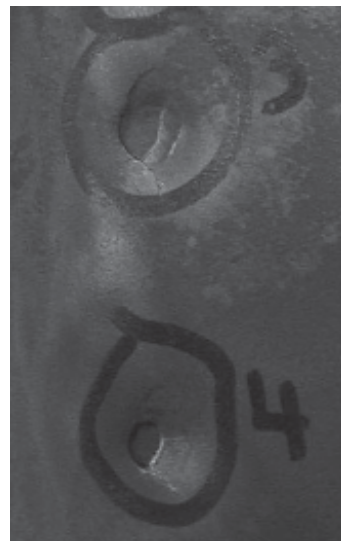
Figure 4. Here we have a closeup of the spot welds shown above. It is clear that the floor pan is failing and that the rear sub frame is pulling away.

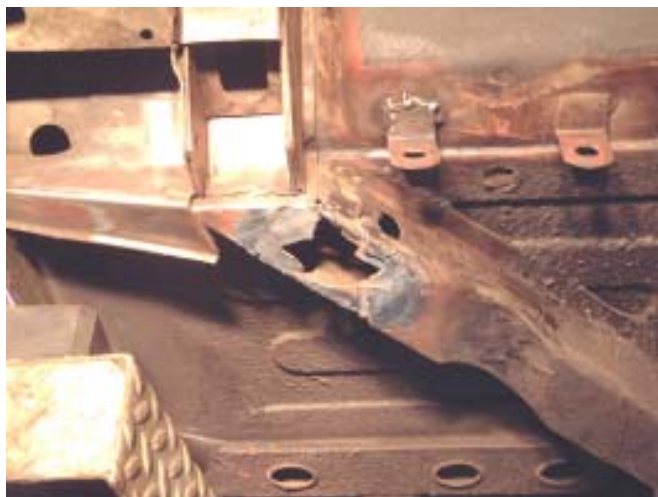
Figure 5. Here we have a typical Tiger frame that has "lost" the Weld-On Traction Master frame mount. The Weld-On mount is one of the weaker points and has often been torn off and re-welded to the X-member several times, resulting in this kind of damage. My recommendation is to switch to the Bolt-On design for the traction bars or eliminate them and use the Dan Walters developed Torque Arm (909 926-1572).

Figure 5 above also shows generally the area that needs to be cleaned and prepared for the kit installation. You need to get down to bare metal to obtain the best welds. If the damage to your chassis is worse than that pictured above, the repairs may well be above the scope of this installation procedure.

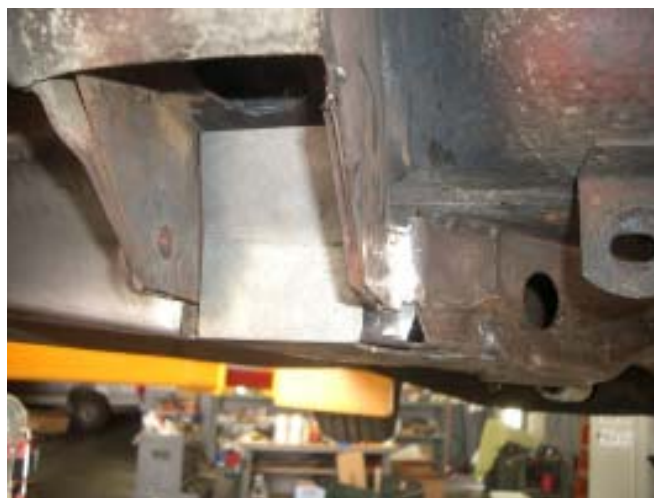
Figure 6. Here is the rectangular piece, bent and placed into position. Note that it is just below flush with the bottom of the chassis. You will be welding this edge, so you don't want it too high.

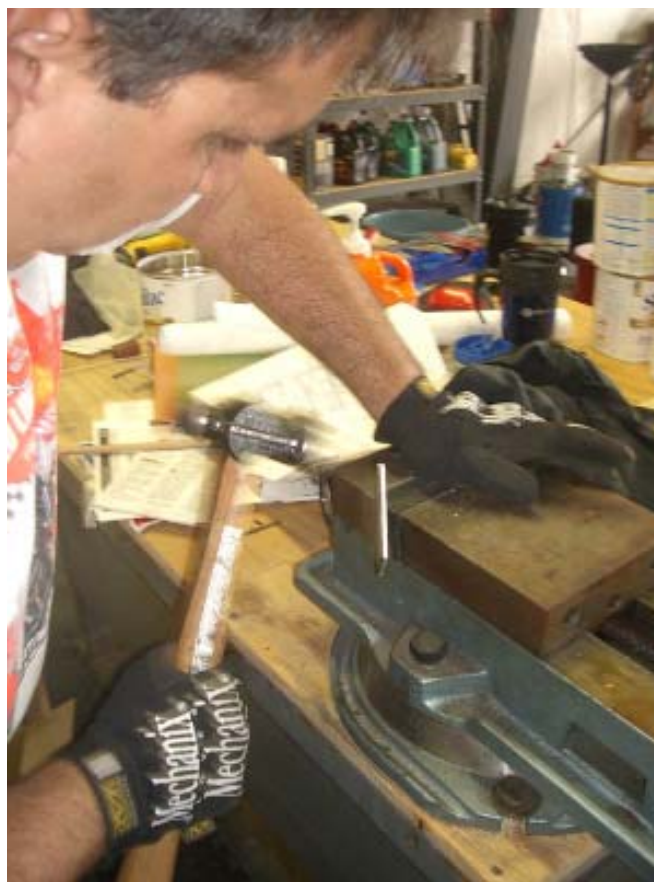
Figure 7. Here you can see how the side plate is bent to fit. Take your time and work this piece gradually. It's easier to bend it a little at a time than to unbend and rebend. If the location of the bend is not obvious to you, cut a replica out of cardboard and fit that first. Then transfer the bend location to the steel piece.

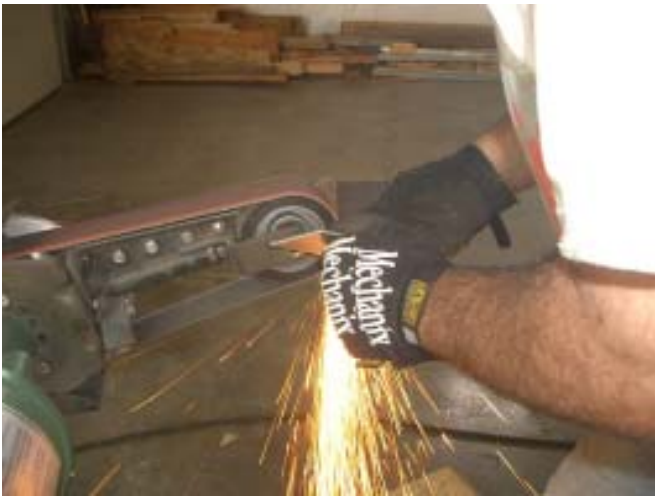
Figure 8. Here we "adjust" the shape to make the perfect fit.

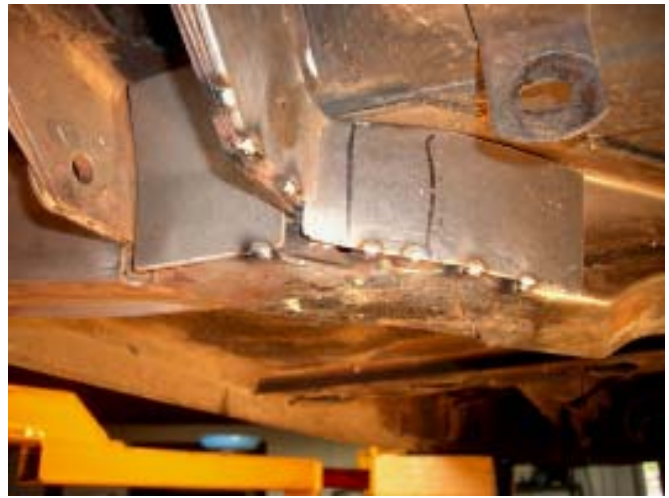
Figure 11. The first two pieces of reinforcement have been fit and tack welded into final position.

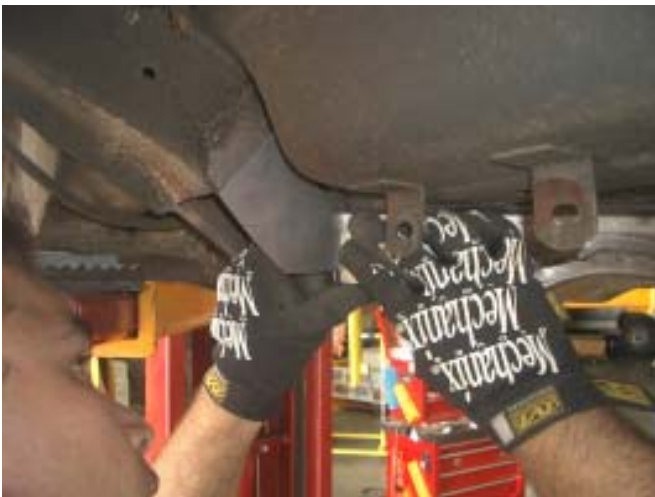
Figure 9. "Fitting" the side piece to the chassis.

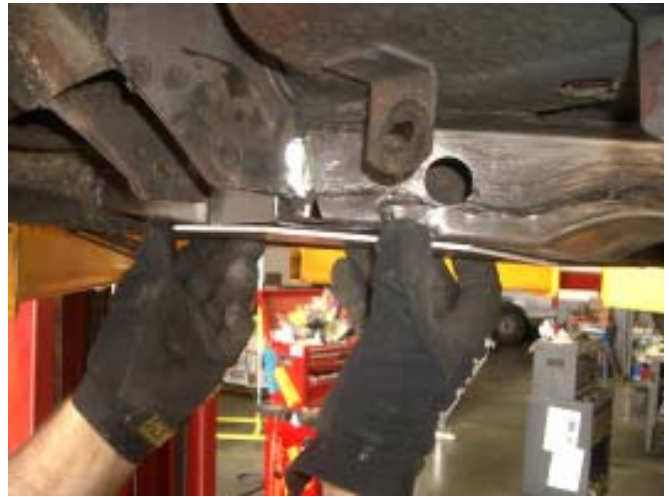
Figure 12. The bottom plate should be a pretty close fit to the side and inside piece where they will be welded together. Some angular adjustment may be necessary with the sanding belt. It's also a good idea to hammer the metal to form joints that can be welded into a tight configuration so that the end result is as smooth and uniform as possible.

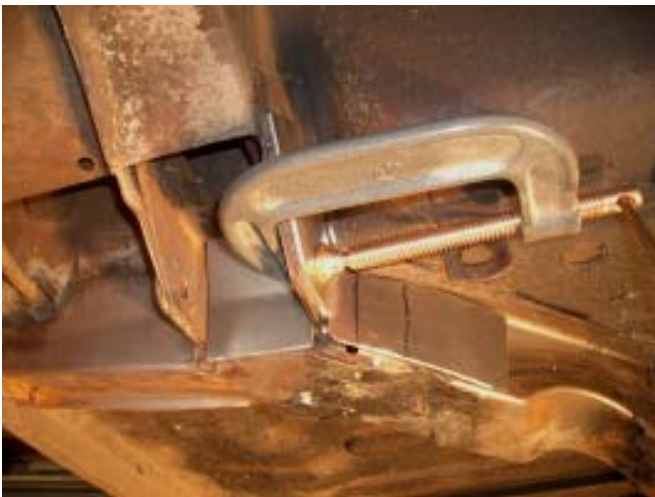
Figure 10. Here's the side piece and the front piece clamped into position, ready for tack welding.

Now that these pieces are fit, we're ready to tack them into position. Remember to leave a little (approximately 1/16") hanging below the OEM structure for attachment of the bottom piece of reinforcement.

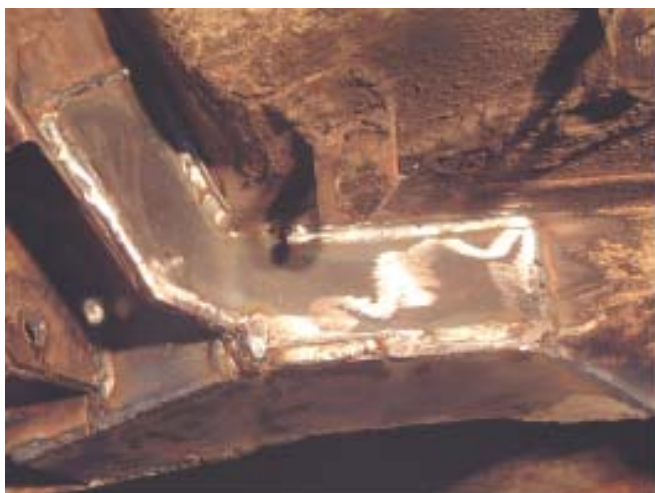
Figure 13. Here we have the finished application to the kit to the rear spring mount. Some minor weld dressing has been done and more can be done, but this gives you the general idea.

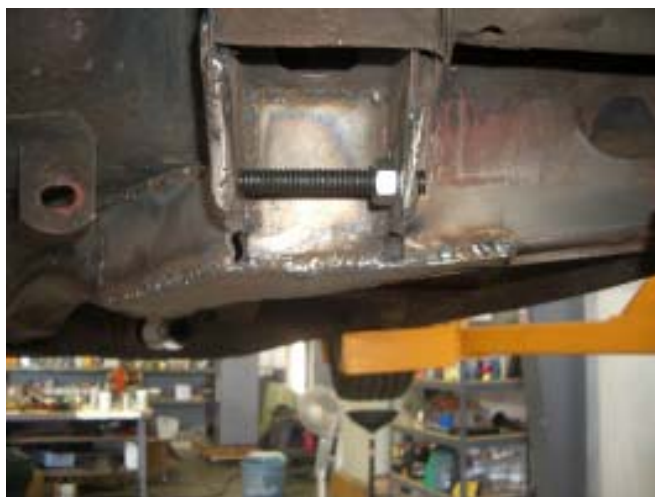
Figure 14. Here's my drill fixture. It's a piece of 7/16 threaded stock with a 1/4" hole drilled through the center. Inserting this piece and tightening the nut as shown, allows the center of the inner hole to be pilot drilled avoiding any enlargement of the original 7/16 hole.

With the welding and grinding done, one task remains and that is to complete the 7/16 Dia hole for the spring mounting bolt. I've done this two ways. One was to use a 7/16 reduced shank drill with my angle drill, and simply drill through from the outside. The second requires a piece of threaded stock with a center hole. This allows a smaller pilot hole to be drilled through the reinforcing plate, which can then be enlarged from the center of the chassis, without gouging the OEM hole as the direct 7/16 drill sometimes does.

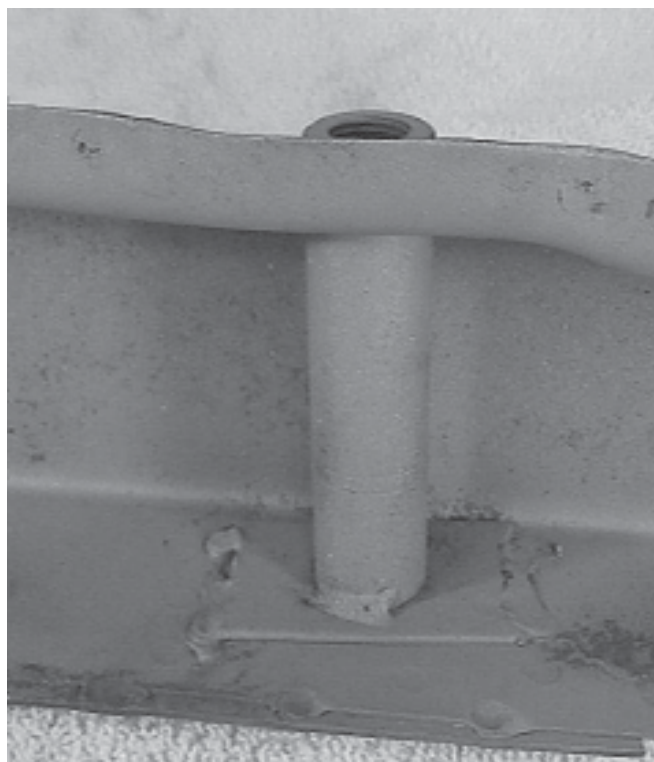
Figure 15. This is what you'd find if you looked inside the front frame horns. As you can see, the tubenut is simply tacked in place.

The front tubenut, located in the frame horn, accepts the connecting bolt from under the crossmember, connecting this structure to the chassis. As you can see in Figure 15, this assembly is rather simple in concept and is now showing up repeatedly as a major weak point in the front of the Tiger chassis. Every application of the brakes applies a twisting load on the front crossmember and the two front bolts take the majority of this loading. The result of 40 plus years of this service frequently points out the weakness of the original design. The tubenut is gradually pulled down in the frame, depressing the area around the tack welds that attach the tubenut to the top rail of the frame stamping. This local "dishing" is only the most visible part of this failure mode. The outside bottom frame flange is spot welded together. As the tubenut is pulled farther and farther down by the crossmember, these spot welds (shown in figure 15 above) begin to fail, opening up the bottom seam of the frame and weakening it substantially. The dished area on top bends and fatigues until it cracks, and then, things get worse in a hurry.

You will also notice this damage whenever you remove the front crossmember. This crossmember connection area of the frame is intended to be very flat and any depression seen in the bottom flange of the frame is a result of the loading and fatigue the chassis has experienced. This dislocation damage should be removed before the reinforcing plate is installed. Figure 17 shows the tooling I developed for pulling the front tube nut back up to the proper position. The outside edges of the frame horn flange may also require cleaning and welding if the OEM spot welds have failed.

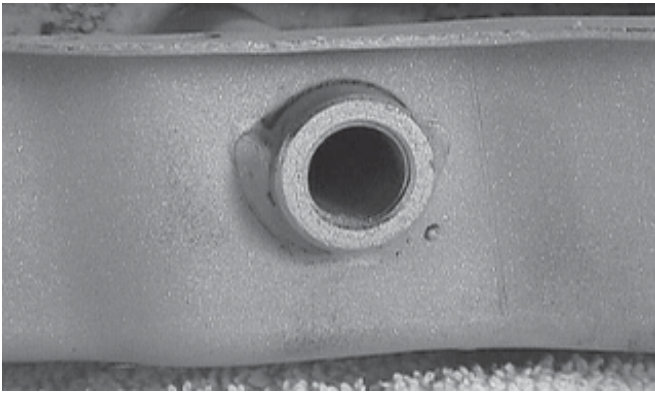
Figure 16. This is an "undamaged" frame connection at the front tubenut. If yours doesn't look like this, some level of repair is in order.

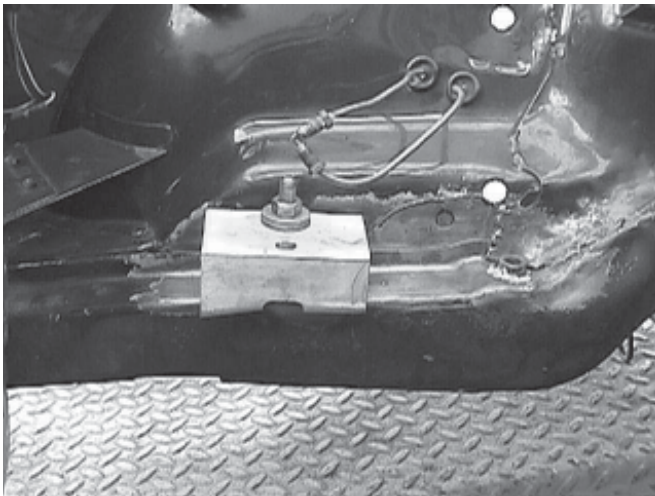
Figure 17. This is a tool I developed to pull the front tube nut back to its original position, without damaging the shape of the frame.

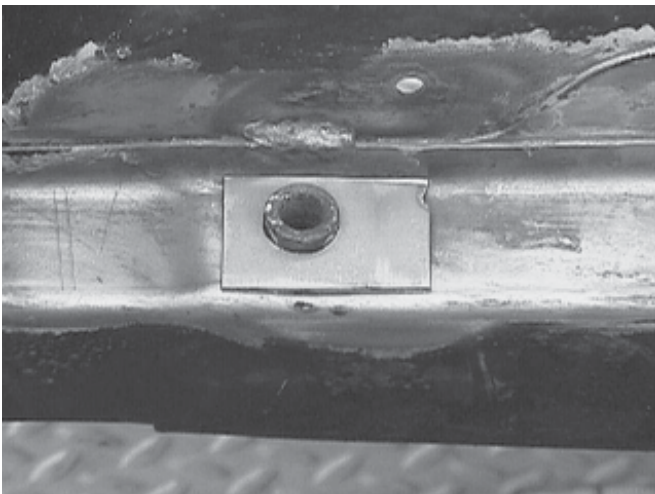
Figure 18 Here's the location of the front tube nut with the reinforcing plate in place, but unwelded. The concept is that this plate, when welded to the top of the tube nut, can carry the loads to the sides of the frame stamping. To assure this load transfer, the perimeter of the reinforcing plate is welded to the frame. In order to get this plate to fit flush as shown, some combination of grinding of the factory welds and countersinking of the hole, from the bottom, is necessary.

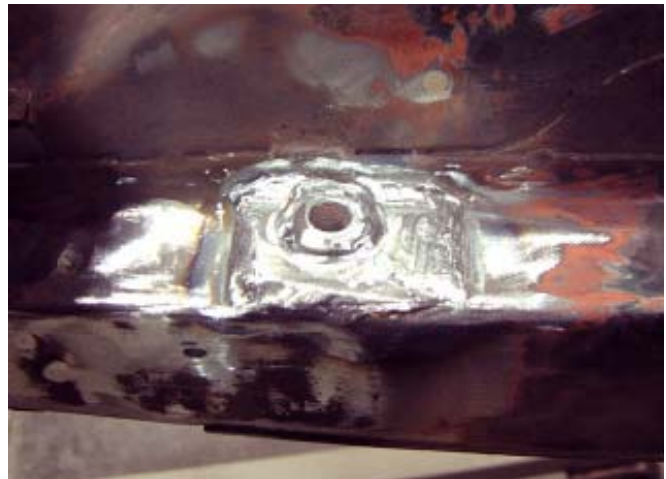
Figure 19. Here's the completed front tubenut reinforcement welded and completed. If you get this reinforcement piece applied before the tube nut starts its typical fatigue failure mode, you can save a lot of future problems and help keep your Tiger structurally sound.

Figure 19 shows the completed reinforcement at the Tubenut. You can make it a little neater with a TIG welder, but in any case, you're going to want to weld all the way around the plate and the tubenut. Be careful when welding the tubenut to the plate, as you don't want to melt into the threads. It's also a good idea to chase the internal 1/2-20 threads after you finish welding. This is a place that collects a lot of debris over the years and chasing the threads will save wear and tear on both the nut and the crossmember connecting bolts.
