# TECHNICAL TIPS

## ON THE SUNBEAM TIGER

March 1999

### Rear Spring Mount Failures and Repairs

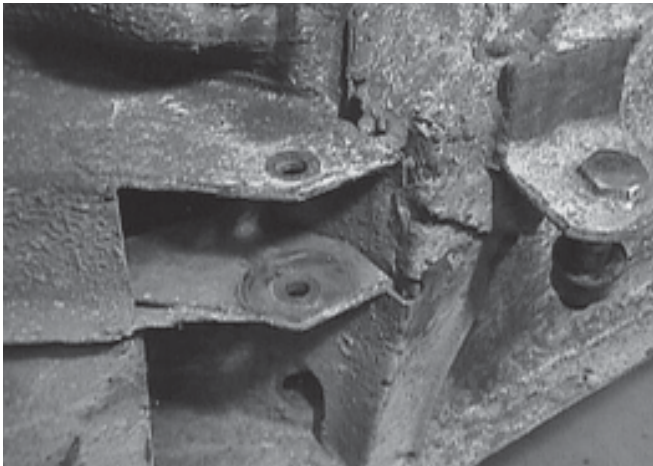
Figure 1 shows an “as found” shot of the inside of the spring hanger. It’s hard to spot the damage with all the road grime and undercoating. In Figure 2, you can see the separated metal inside the spring hangers and Figure 3 shows a crack in the triangular shaped tie plate.

Figure 1. Inner Tie Plate Fracture

The structural faults depicted here include complete cracking and failure of the inner tie plates, substantial cracking of the triangular tie plate to the perimeter of the floor pan, and failure of the welds inside the spring hanger that tie the rear sub frame to the X member.

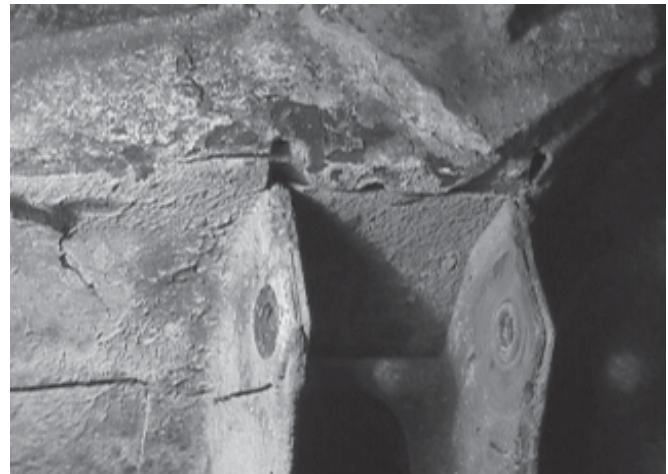
Figure 3. Crack in Triangular Gusset Plate

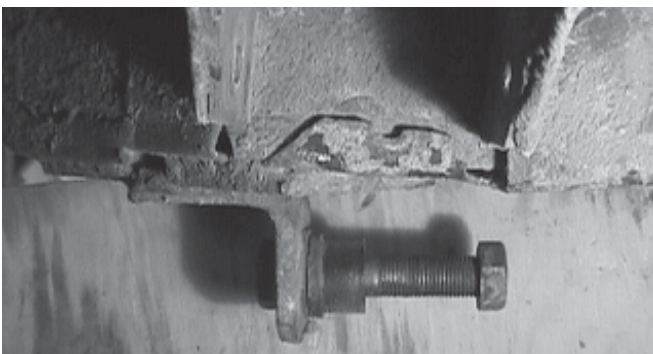
Figure 2. Broken Weld Inside Spring Hanger

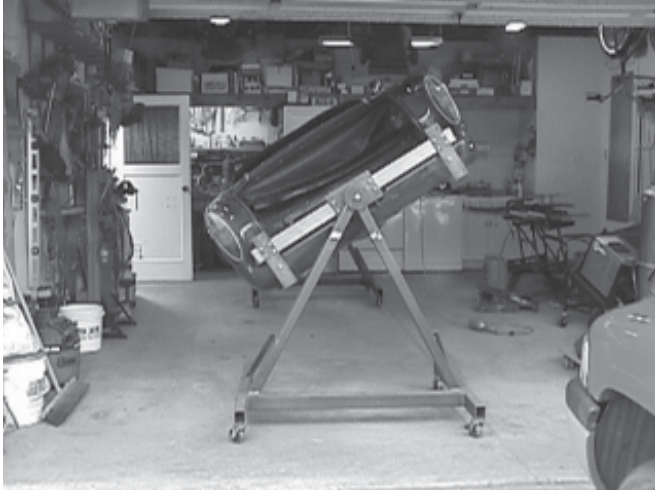
In Figure 4 we have the recommended method to get at these areas in order to make the optimum repairs. The rotisserie is not a necessity, but it sure makes for a better repair process. The ability to thoroughly clean the chassis and to weld in comfortable positions can make a world of difference to the quality of the job.

Figure 4. Tiger on the Rotisserie

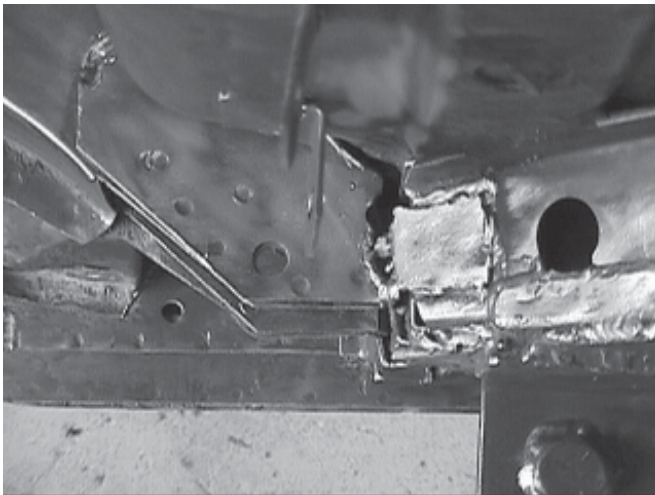
Figure 5. Broken Inner Tie Plate

Now we can really see what's been going on!. Figure 5 shows the clear separation of the inner tie plate with a gap of about a quarter inch. Careful observers will also observe the gap above the spring mount where the rear sub-frame is beginning to pull away from the floor pan. This damage was detected just in time to prevent severe dislocation problems.

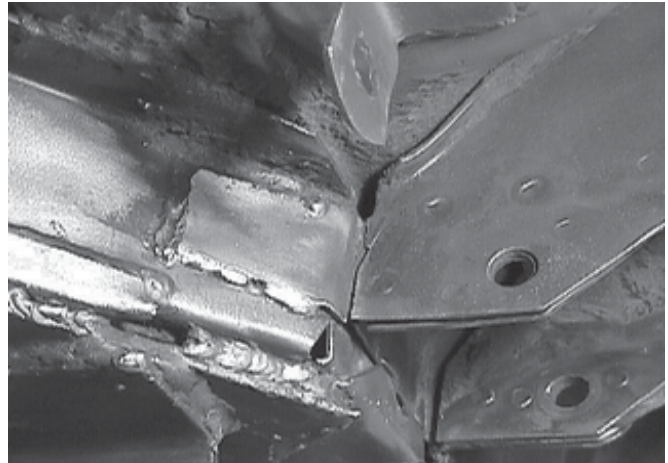
Figure 6 indicates the crack on the opposite side which has not moved as far from it's original location.

Figure 6. Tie Plate Failure on the other side

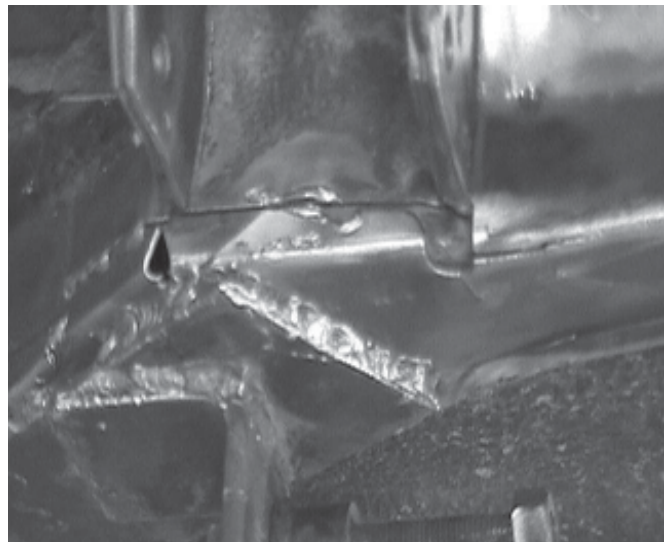
Figure 7 shows the failed weld inside the mount between the vertical wall of the spring hanger. Look closely and you'll also see the crack in the triangular plate. You can also see in these shots, a reinforcing plate that was added to remount the "Weld on" traction bars. If you find damage to this area and intend to re-install the bars, appropriate repairs not covered here are recommended.

Figure 7. Cracked Gusset Plate

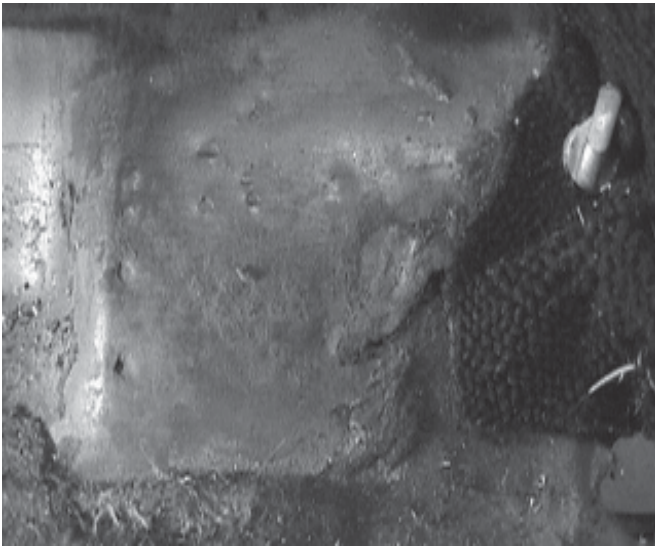
Moving inside the body, Figure 8 is an "as found" photo of the spot welds that hold the front of the rear sub frame to the floor pan. Don't see much in this photograph? Wait till we get this area cleaned up.

Figure 8. The "Other Side" of the spring mount

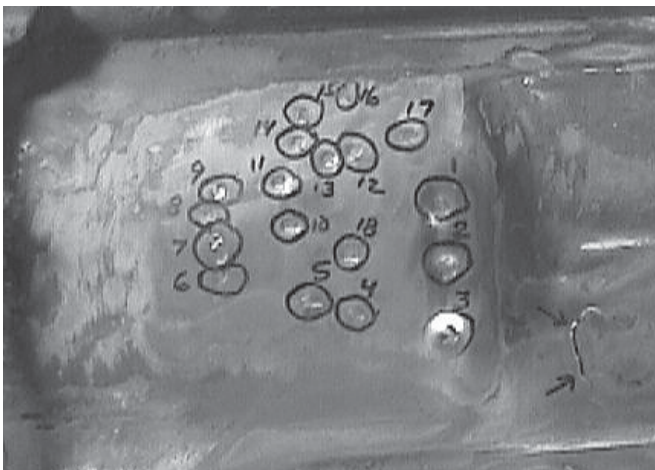
In Figure 9 and 10 we've done our cleaning and have circled the spot welds we found connecting the floor pan to the rear sub-frame.

We're up into the high teens in weld count and careful observation of the inside weld group indicates major sheet-metal failures on both sides of the chassis.

Figure 9. This is the same area after cleanup

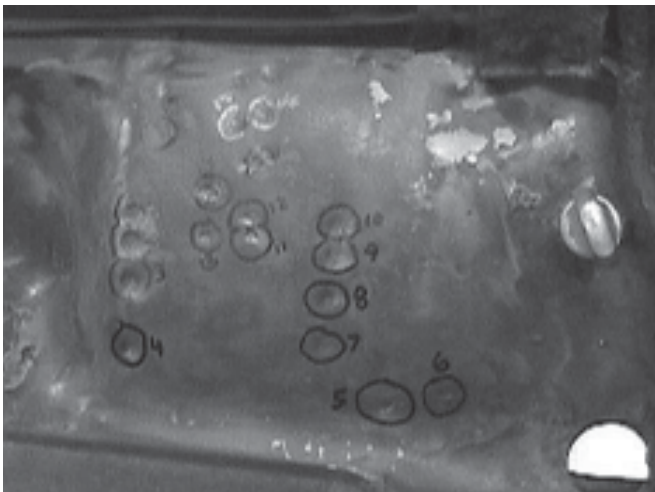
Figure 10. The Left side Spot Welds to the Sub Frame

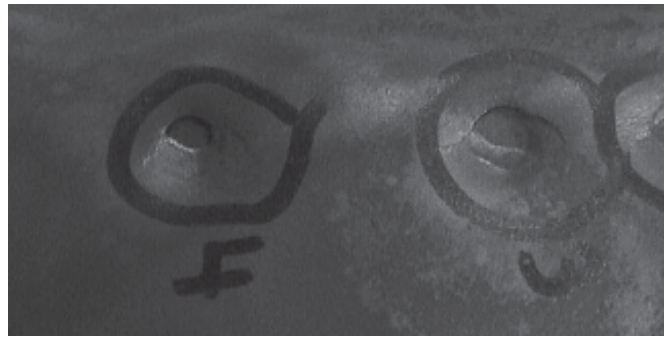
Figure 11. Closeup of Fractured Spot Welds

Figure 11 is a close-up of one of these areas. The tearing of the floor pan at the perimeter of the spot welds is obvious with the worst damage at the bottom.

The recommended repair methodology for this kind of sheet-metal failure begins with TIG or MIG welding at the edge of the rear sub-frame flange to the floor pan from the bottom and plug welding the failed spot welds from the top. A low or pulsed weld heat should be used to prevent burning through the floor pan (except at the plug welds). A skip welding technique would be preferred to continuous welding.

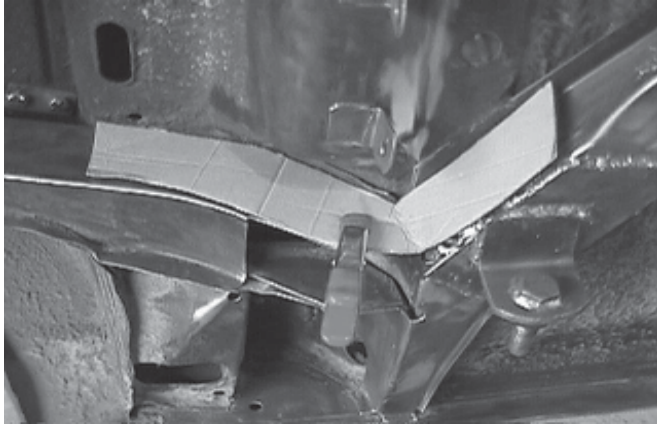
Figure 12. "New" Inner Tie Plate

Figures 12 and 13 show the proposed reinforcements to be added over the repaired areas. The pieces shown here are cardboard templates. When these pieces are made they will be cut from a mild steel stock from 0.108 to 0.120 thick (12 and 11 gage). They will also be cut with several 3/4" diameter holes to allow for plug welding to the sides of the frame sections. Again, skip welds would be preferred.

Keep in mind that you're going to have to drill the two 7/16" holes for the spring mounting bolts. It's pretty easy to drill the outer hole from the inside of the chassis by going through the existing holes, but unless you have a right angle drill handy, the inside reinforcing plate should be marked, drilled and aligned with the existing hole before you weld it into location.

The new plate simulations shown should give a substantially increased load bearing area to prevent further damage to this chassis. It's a good idea to get the base metal in the area of your welds good and clean, free from rust. The minimum should be a good wire brushing. The cleaner your weld areas are, the better your welds are likely to be.

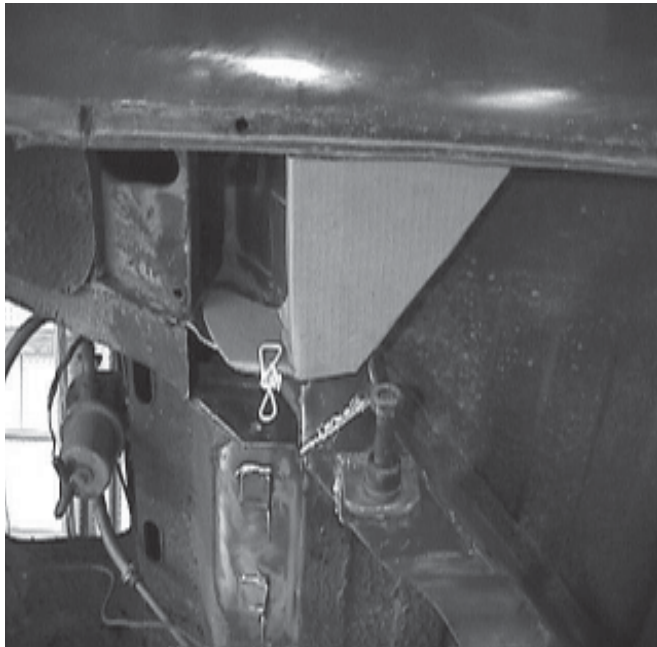
Figure 13. "New" triangular exterior plate
