Crossmember Inspection

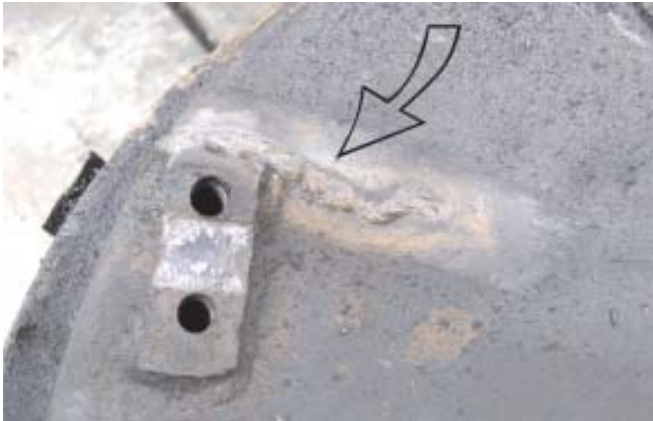
Welding the perimeter of the spacer pads is a practice I strongly disagree with and the next shot will pretty much tell you why. The extra weld creates a "heat affected zone" next to the weld bead and this leads to an increase of stress at this location.

Figure 1. Here's a tell tale clue that this crossmember has seen previous repairs in its service life. The arrow shows the bead of weld that someone has placed over a former crack in the shell. You will also note in these photos that the entire perimeter of the spacer plates have been welded to the shell.

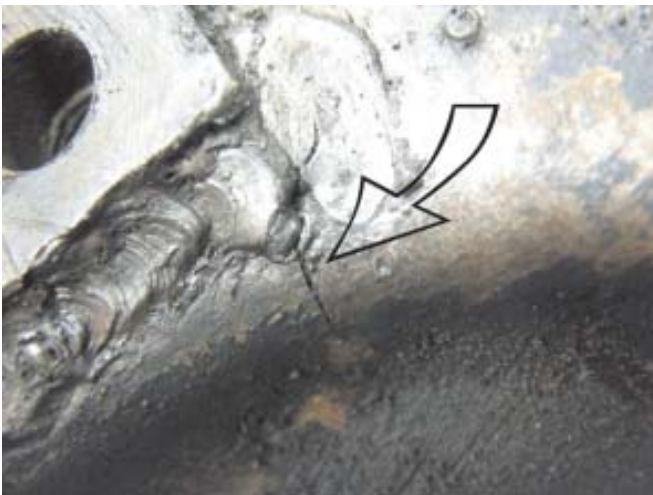
Figure 2. On the opposite front pad, a little wire brushing reveals a new crack starting to propagate. This is a significant and dangerous sign and should not be ignored.

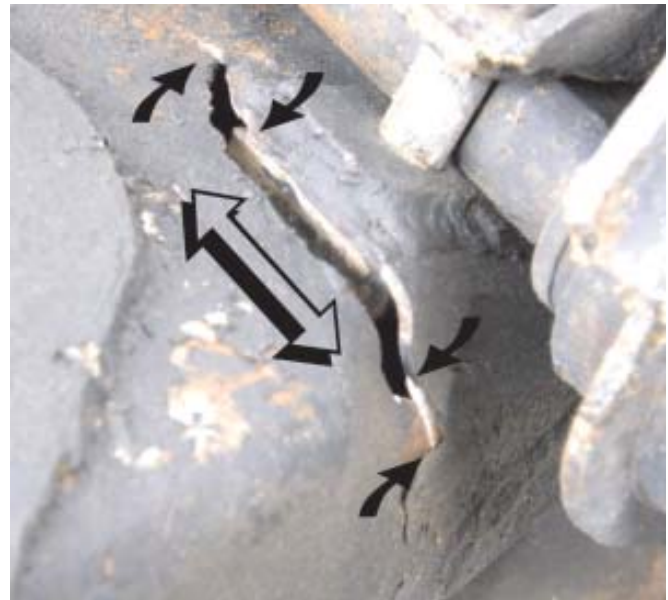
Figure 3. There's a lot of information in this photograph when you know how to interpret it. The two pairs of black arrows show the "new" crack propagation. The double headed arrow shows that portion of the crack that had previously fractured and propagated during service until it was well beyond the spacer pad. Note that the "old" fracture precisely follows the edge of the weld bead. That is typical. The ultimate cause of the dislocation shown was an accidental impact with a curb, but the structural failure was simply waiting to happen. The more these cracks propagate, the less energy it takes to open them up and cause a potential accident.

These pictures are intended to encourage you to have a detailed look at your suspension, to prevent problems before they occur. This crossmember is non-repairable in my estimation and this Tiger will be receiving one of my Alpine conversion crossmembers to get it back on the road. Tom Hall
